# DRAFT ASSURANCE REPORT ON DISCLOSED PUBLIC INFRASTRUCTURE PROJECTS AND CONTRACTS BY THE MINISTRY OF WORKS AND TRANSPORT ON CONSTRUCTION OF MARKET AT PLOT 422, BLOCK 369 LUKAYA TOWN COUNCIL KALUNGU DISTRICT COMPLETION OF PHASE 1 AND PHASE 2 WORKS PROC REF: MOWT/WOKS/14-15/00340

**CoST Uganda Chapter**

**OCTOBER, 2018**

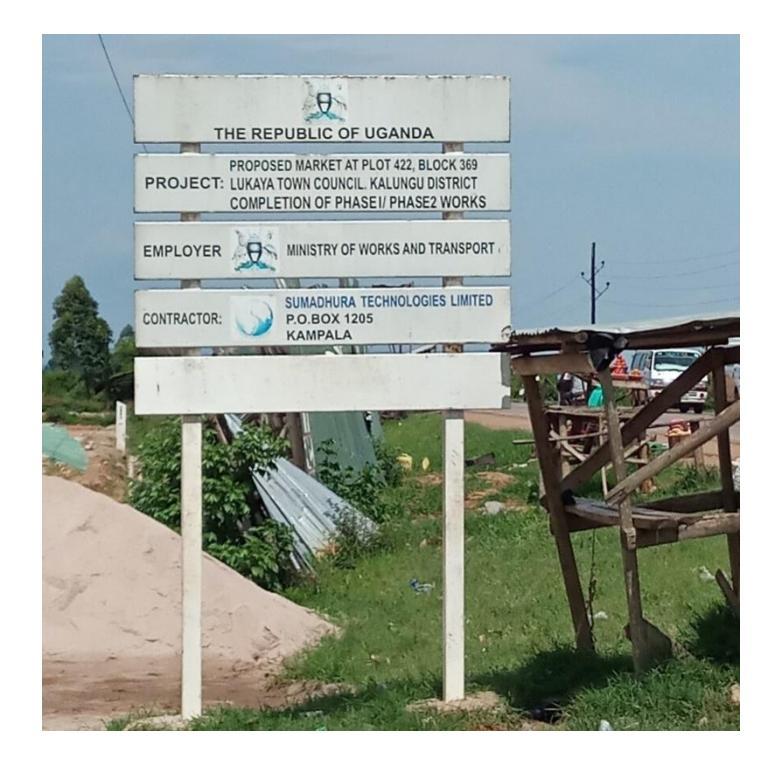
Figure 3: Project Signage

- A project sign board was observed for only Phase II of the project. However, some panels were blank while others were missing.
- Information not originally placed on the project signage includes, contract sum and project duration, project scope, funders, project manager and or supervisor. A signboard for phase I was not in place at the time of visiting the site. There is need to elaborate scope of Phase II to mixing up Phase I with Phase II works

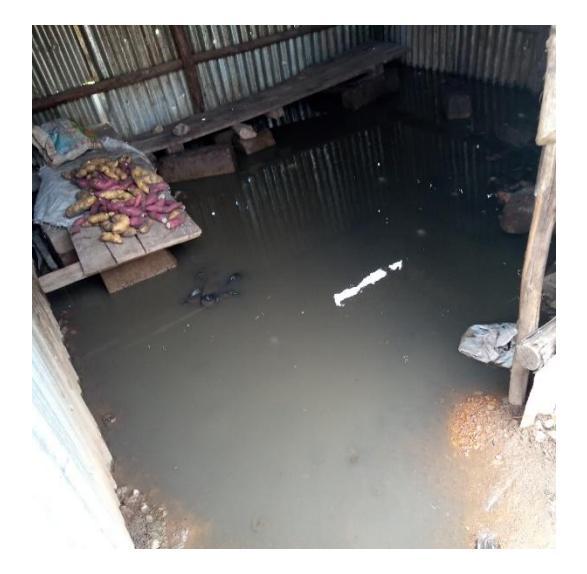
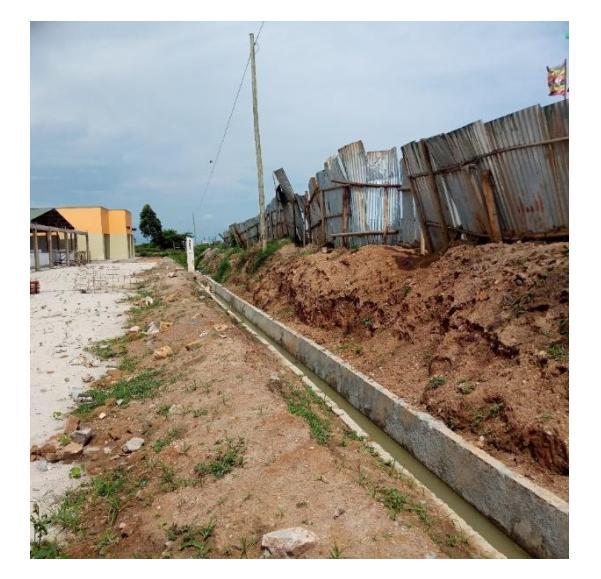
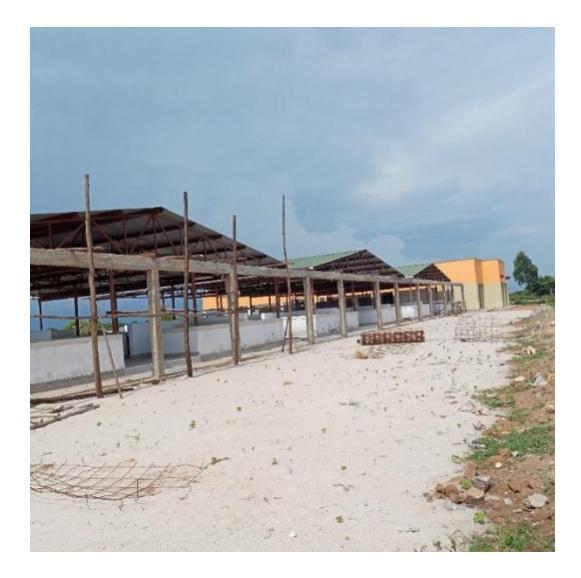
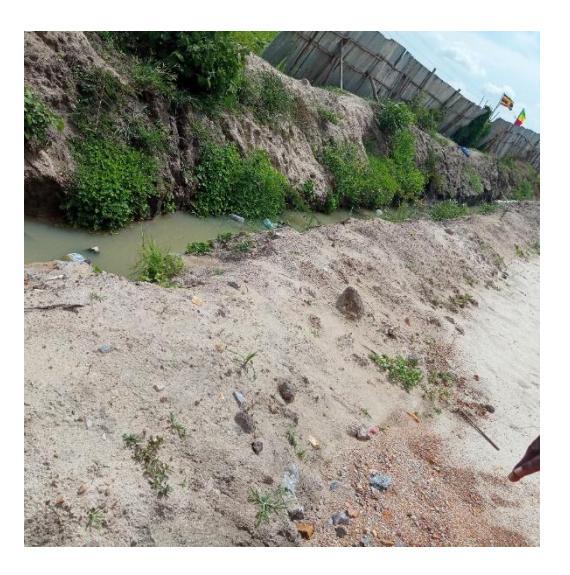
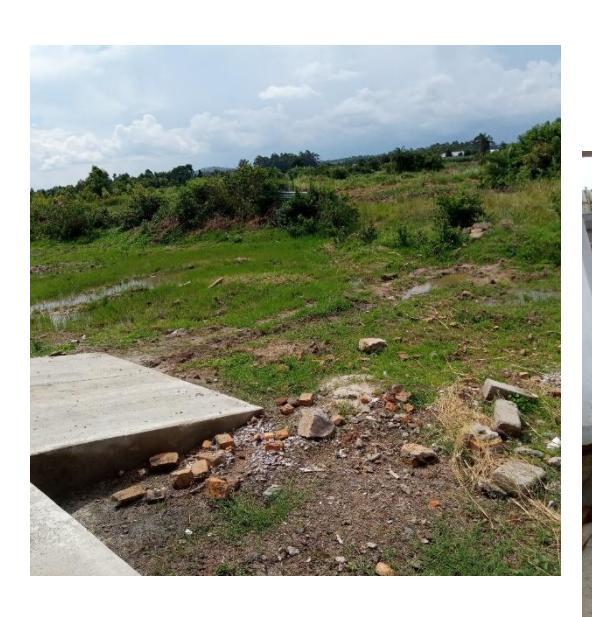
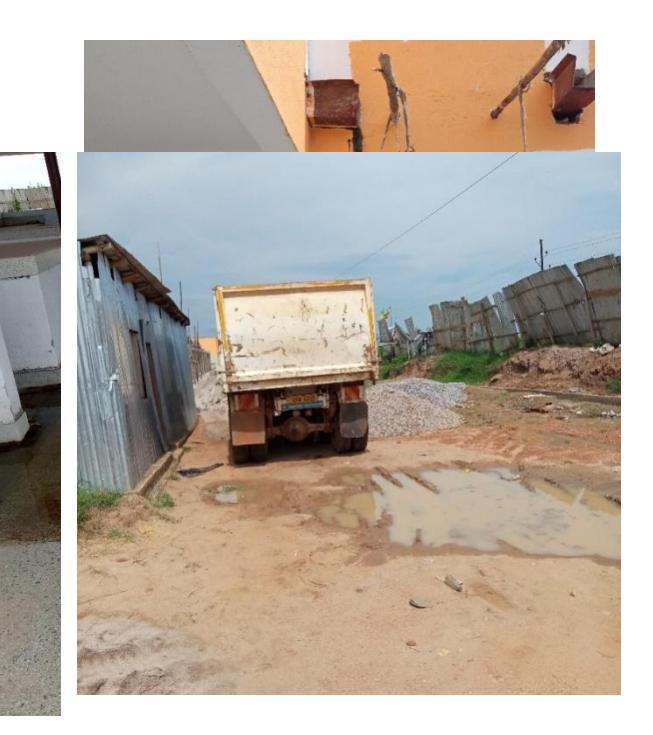
Figure 2: Environmental concerns

- Environmental approval documentation such as the NEMA certificate of approval and the respective approval conditions were not disclosed.
- During the site visit, it was observed that the site did not have sufficient safety and protection material. In some cases deep areas were not properly cordoned off.

- The methodology of constructing a drain in a water logged zone was archaic and not as per international best engineering practice. No evidence of the quality control data for concrete cast was disclosed. Use of a water pump may give more successful results. It was not clear whether the drain was following rule of thumb or a welldocumented design

- Non-disclosure of the design for the drainage system of the area.
- Non-disclosure of the structural and geotechnical design for the the area.
- Local people still traverse construction site due to vandalism and or collapse of sections of the fence. All footpaths used by local people should be fenced.

- The project is being implemented in a swampy area and floods oftenly. This may likely cause contaminant and pollutant ingress as well as impact on the usability and structural integrity of the structure

- The market requires an adequate drainage with a good outflow plan that should be informed by an adequate drainage design.
- Occupational health and safety issues should be integrated in the design to avoid risk to the market users and surrounding communities
